**Flood Control Project Maintenance  
Levee Inspections**  
**LMA District Cover Sheet**  
**Spring 2019 Levee Inspection Results**

**Butte County Department of Public Works**

**Spring 2019 Levee Inspection Results**

Waterway			Bank	Unit Miles
Unit No. 01 Mud Creek			Right	6.80
	Spring (March - May)	Summer (June - August)	(September - November) Fall	Winter (December - February)
Unit Maintenance Rating (Fall Only)				
Date of Inspection	4/10/2019 - 4/10/2019			
DWR Inspector	Makar Sokol			
Accompanied By

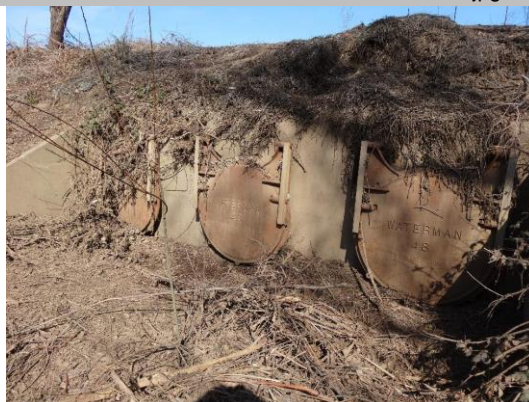
Photo 2 of 3 : UCIP\_SP\_2019\_32085\_58584.jpg

WS view: U type concrete headwall, pipes, and flapgates on levee slope. Soil/mud on outlet box. Vegetation debris blocking outlet box

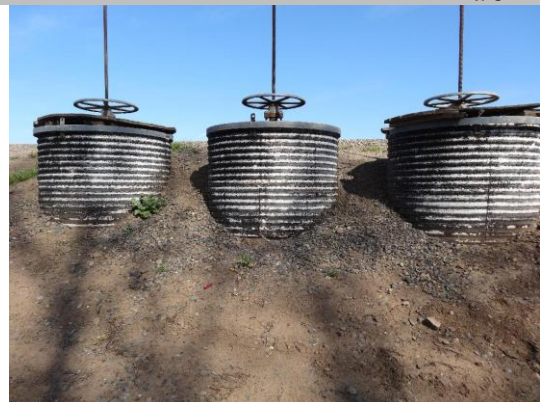
Photo 1 of 3 : UCIP\_SP\_2019\_32087\_58592.jpg

Comment Code					
Inspector Comment					
FS_ID:32087					
DS_ID:19261					
EP_NO: N/A					
Repair Type: Non-Urgent					
Crossing Status: Found					
UCIP Comments: Slide gates in CMP risers on waterside shoulder.Needs cleaning and clearing on both pipe ends.					
FIELD_STRUCT_DESC: 3 of 3: 48-inch corrugated metal gravity drainage pipe through the levee, 18 feet below the crown. Flap gate on the waterside (WS) end. Slide gate in a corrugated metal pipe (CMP) riser on the WS shoulder. Concrete U-shaped headwall on each end. Grouted riprap apron on the landside (LS) end. Grouted riprap spillway on the WS end. [Additional Reference(s): DWR Levee Log, 1992. USACE Sacramento O&M Manual 504, May 1965, (HLM 7.46)].					
FS Date: 2/25/2014

WS view: slide gates in CMP risers on waterside shoulder.

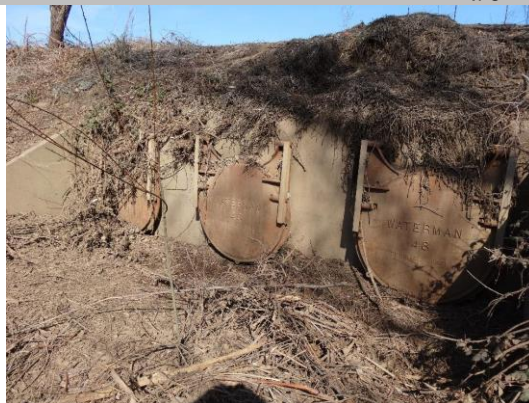
Photo 2 of 3 : UCIP\_SP\_2019\_32087\_58591.jpg

Comment Code						
Inspector Comment						
FS_ID:32087 DS_ID:19261 EP_NO: N/A Repair Type: Non-Urgent Crossing Status: Found UCIP Comments: Slide gates in CMP risers on waterside shoulder.Needs cleaning and clearing on both pipe ends. FIELD_STRUCT_DESC: 3 of 3: 48-inch corrugated metal gravity drainage pipe through the levee, 18 feet below the crown. Flap gate on the waterside (WS) end. Slide gate in a corrugated metal pipe (CMP) riser on the WS shoulder. Concrete U-shaped headwall on each end. Grouted riprap apron on the landside (LS) end. Grouted riprap spillway on the WS end. [Additional Reference(s): DWR Levee Log, 1992. USACE Sacramento O&M Manual 504, May 1965, (HLM 7.46)]. FS Date: 2/25/2014

WS view: U type concrete headwall, pipes, and flapgates on levee slope. Soil/mud on outlet box. Vegetation debris on outlet box

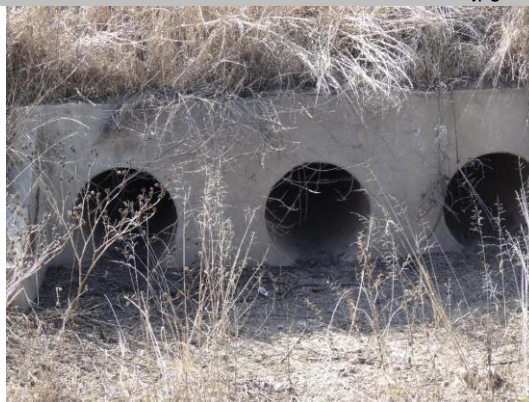
Photo 3 of 3 : UCIP\_SP\_2019\_32087\_58590.jpg

LS view: U type concrete headwall and CMPs on levee slope. Soil/mud on inlet box.

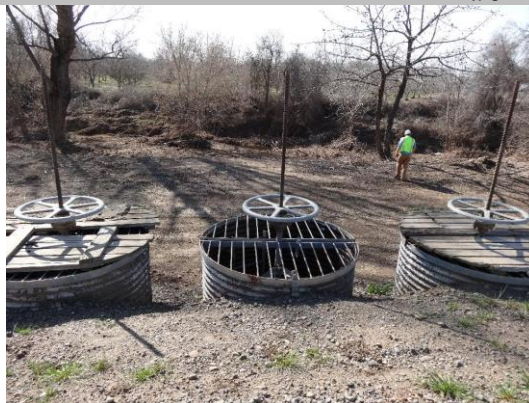
Photo 1 of 3 : UCIP\_SP\_2019\_32086\_58589.jpg

Comment Code					
Inspector Comment					
FS_ID:32086 DS_ID:19260 EP_NO: N/A Repair Type: Non-Urgent Crossing Status: Found UCIP Comments: Slide gates in CMP risers on waterside shoulder.Needs cleaning and clearing of debris. FIELD_STRUCT_DESC: 2 of 3: 48-inch corrugated metal gravity drainage pipe through the levee, 18 feet below the crown. Flap gate on the waterside (WS) end. Slide gate in a corrugated metal pipe (CMP) riser on the WS shoulder. Concrete U-shaped headwall on each end. Grouted riprap apron on the landside (LS) end. Grouted riprap spillway on the WS end. [Additional Reference(s): DWR Levee Log, 1992. USACE Sacramento O&M Manual 504, May 1965, (HLM 7.46)]. FS Date: 2/25/2014

WS view: slide gates in CMP risers on waterside shoulder.

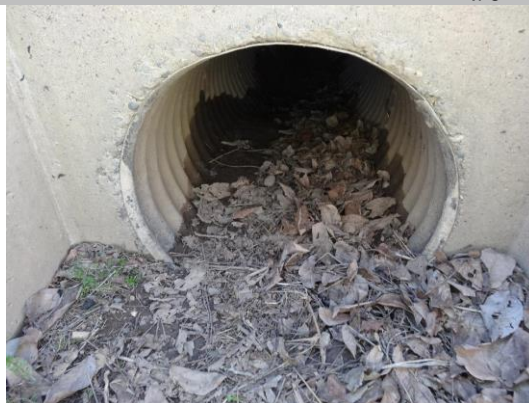
Photo 2 of 2 : UCIP\_SP\_2019\_31129\_57035.jpg

Comment Code						
Inspector Comment						
FS_ID:31129						
DS_ID:19254						
EP_NO: N/A						
Repair Type: Non-Urgent						
Crossing Status: Found						
UCIP Comments: Debris in inlet pipe, needs cleaning and clearing.						
FIELD_STRUCT_DESC: 24-inch corrugated metal gravity drainage pipe						
through the levee, 18 feet below the crown. Flap gate on the waterside						
(WS) end. Concrete U-shaped headwall on each end. Grouted riprap						
apron on the landside (LS) end. Grouted riprap spillway on the WS end.						
[Additional Reference(s): DWR Levee Log, 1992. USACE Sacramento						
O&M Manual 504, May 1965, (HLM 8.09)].						
FS Date: 2/25/2014

LS view: U type concrete headwall and CMP on levee slope. Soil/mud and vegetation on inlet box.

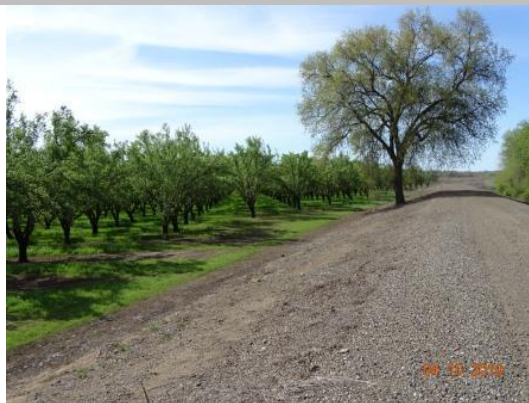
Photo 1 of 1 : SP\_2019\_NA0003\_66\_1\_20190415\_00001.jpg

LM Start	0.00	Rating **	A	Issue No.	1
LM End	0.26	Issue Type +	Ma	Location *	LS
Category	Earthen Levee			GPS Latitude/Longitude	
				Start	End
Item	Vegetation			39.733076 °	39.736421 °
				-121.930273 °	-121.928479 °
DWR ID	DWR_NA0003_02A_s_2012_1				
Comment Code					
V1 : Control annual grass and weeds on the levee slopes and easements.					
Inspector Comment					
The annual vegetation is well maintained.

View of the well maintained vegetation on the landside slope. Spring 2019.

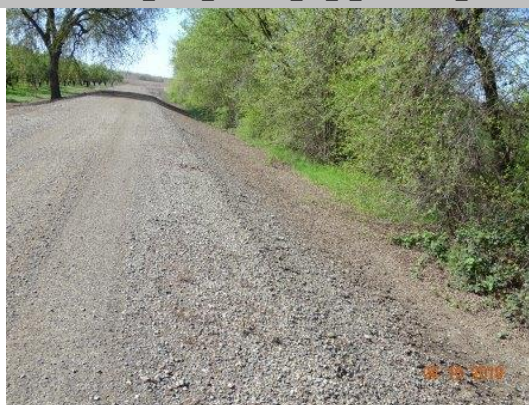
Photo 1 of 1 : SP\_2019\_NA0003\_66\_2\_20190415\_00002.jpg

LM Start	0.00	Rating **	A	Issue No.	2
LM End	0.26	Issue Type +	Ma	Location *	WS
Category	Earthen Levee			GPS Latitude/Longitude	
				Start	End
Item	Vegetation			39.733077 °	39.736420 °
				-121.930273 °	-121.928478 °
DWR ID	DWR_NA0003_02A_s_2012_2				
Comment Code					
V1 : Control annual grass and weeds on the levee slopes and easements.					
Inspector Comment					
The annual vegetation is well maintained.

View of the well maintained vegetation on the waterside slope. Spring 2019.

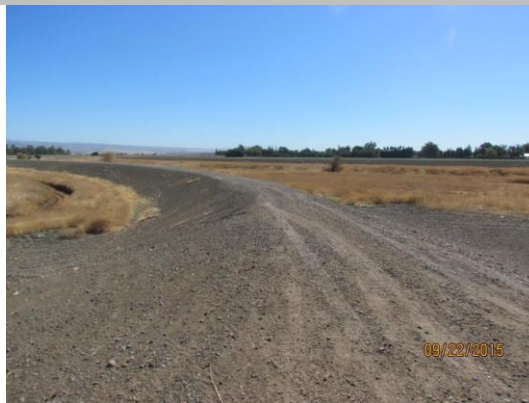
Photo 1 of 1 : SP\_2019\_NA0003\_67\_12\_20190325\_00002.jpg

LM Start	0.02	Rating **	M	Issue No.	12
LM End	0.02	Issue Type +	Ma	Location *	LS
Category	Earthen Levee			GPS Latitude/Longitude	
				Start	End
Item	Slope Stability			39.785970 °	39.785970 °
				-121.882797 °	-121.882797 °
DWR ID	DWR_NA0003_03_f_2015_12				
Comment Code					
S3 : Repair the levee slope damaged by vehicle traffic and prevent access where possible.					
Inspector Comment					
Repair the erosion on both slopes caused by motorcycle traffic.

View of the erosion on both slopes caused by motorcycle traffic.

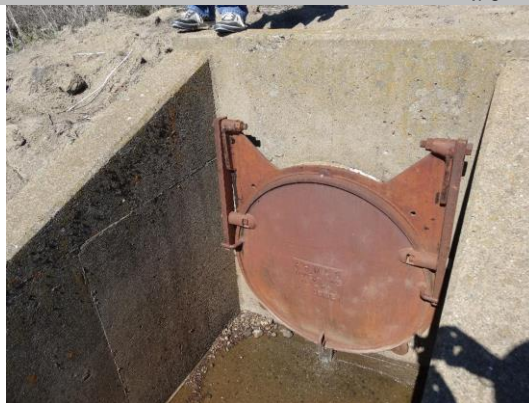
Photo 1 of 3 : UCIP\_SP\_2019\_51844\_58602.jpg

Comment Code						
Inspector Comment						
FS_ID:51844 DS_ID:19262 EP_NO: N/A Repair Type: No Action Needed Crossing Status: Found UCIP Comments: 05/16/2017 Crossing has been downgraded from Non-Urgent to No Action Needed. The flap gate appears to be in good working order based on the photos, and the small pile of debris not enough to warrant Non-Urgent rating. (K. Fazel - UCIP)03/11/2014:Slide gate in CMP riser on waterside.The culvert was working during field inspection. (P. Amatya - DWR) FIELD_STRUCT_DESC: 42-inch corrugated metal gravity drainage pipe through the levee, 14 feet below the crown. Flap gate on the waterside (WS) end. Slide gate in a corrugated metal pipe (CMP) riser on the WS slope. Concrete U-shaped headwall on each end. Grouted riprap apron on the landside (LS) end. Grouted riprap spillway on the WS end. [Additional Reference(s): DWR Levee Log, 1992. USACE Sacramento O&M Manual 504, May 1965, (HLM 0.09)]. FS Date: 3/11/2014

WS view: U type concrete headwall, pipe, and flapgate on levee slope.

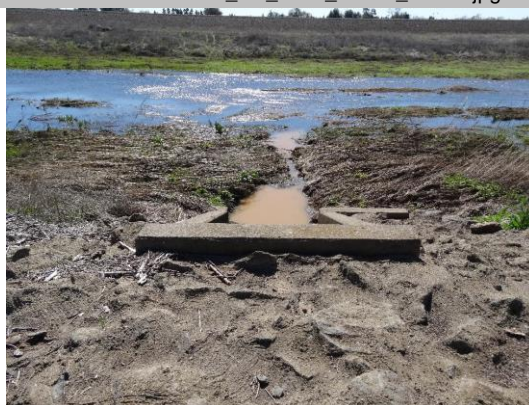
Photo 2 of 3 : UCIP\_SP\_2019\_51844\_58601.jpg

WS view: U type concrete headwall of CMP culvert on levee slope. Grouted riprap levee slope and spillway.

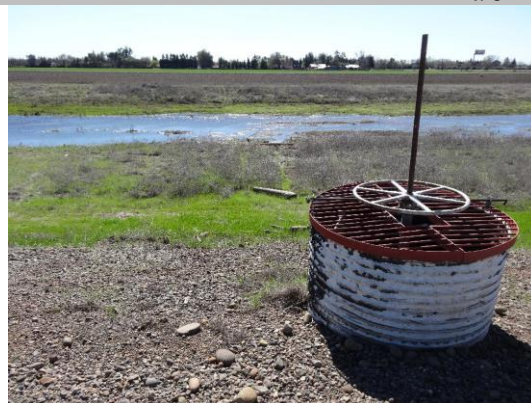
Photo 3 of 3 : UCIP\_SP\_2019\_51844\_58600.jpg

Comment Code						
Inspector Comment						
FS_ID:51844 DS_ID:19262 EP_NO: N/A Repair Type: No Action Needed Crossing Status: Found UCIP Comments: 05/16/2017 Crossing has been downgraded from Non-Urgent to No Action Needed. The flap gate appears to be in good working order based on the photos, and the small pile of debris not enough to warrant Non-Urgent rating. (K. Fazel - UCIP)03/11/2014:Slide gate in CMP riser on waterside.The culvert was working during field inspection. (P. Amatya - DWR) FIELD_STRUCT_DESC: 42-inch corrugated metal gravity drainage pipe through the levee, 14 feet below the crown. Flap gate on the waterside (WS) end. Slide gate in a corrugated metal pipe (CMP) riser on the WS slope. Concrete U-shaped headwall on each end. Grouted riprap apron on the landside (LS) end. Grouted riprap spillway on the WS end. [Additional Reference(s): DWR Levee Log, 1992. USACE Sacramento O&M Manual 504, May 1965, (HLM 0.09)]. FS Date: 3/11/2014

WS view: slide gate in CMP riser on waterside shoulder.

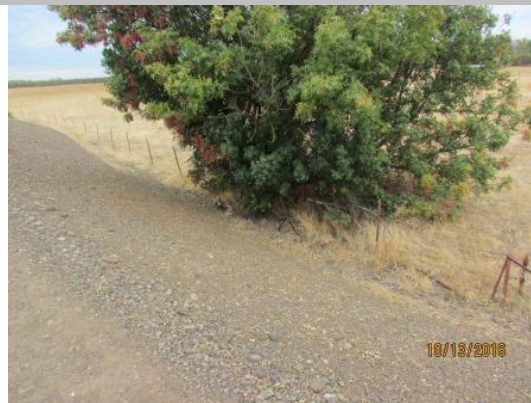
Photo 1 of 1 : SP\_2019\_NA0003\_67\_15\_20190325\_00004.jpg

LM Start	0.35	Rating **	M	Issue No.	15
LM End	0.35	Issue Type +	Ma	Location *	LS
Category	Earthen Levee			GPS Latitude/Longitude	
				Start	End
Item	Trim / Thin Trees			39.785704 °	39.785704 °
				-121.877004 °	-121.877004 °
DWR ID	DWR_NA0003_03_f_2016_15				
Comment Code					
T1 : Trim trees to at least five feet above ground level.					
Inspector Comment

View of the overgrown tree along the landside slope.

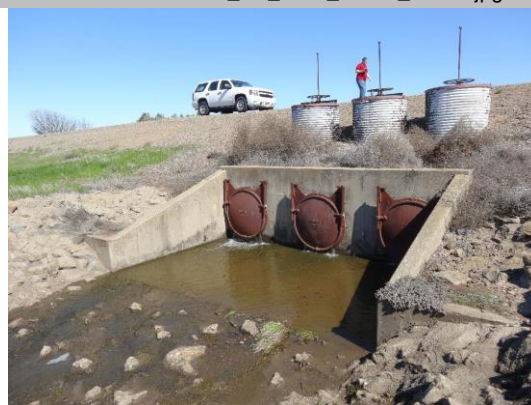
Photo 1 of 2 : UCIP\_SP\_2019\_32104\_58606.jpg

LM Start	0.39	Rating **	A/W	Issue No.	29
LM End	0.39	Issue Type +	Ma	Location *	
Category	Supplemental			GPS Latitude/Longitude	
				Start	End
Item	DWR UCIP LMA Responsibility			39.785262 °	39.785262 °
				-121.876622 °	-121.876622 °
DWR ID	19278				
Comment Code					
Inspector Comment					
FS_ID:32104 DS_ID:19278 EP_NO: N/A Repair Type: No Action Needed Crossing Status: Found UCIP Comments: Slide gate in CMP riser on waterside.The culvert was working during the field visit. FIELD_STRUCT_DESC: 1 of 3: 48-inch corrugated metal gravity drainage pipe through the levee, 11.7 feet below the crown. Slide gate in a riser well on the waterside (WS) slope. Concrete U-shaped headwall on each end. Flap gate on the WS end. Grouted riprap outlet channel on the WS. [Additional Reference(s): DWR Levee Log, 1992. USACE Sacramento O&M Manual 504, May 1965, (HLM 0.39)]. FS Date: 3/11/2014

WS view: U type concrete headwall and three CMPs with slide gates on levee slope. Grouted riprap spillway.

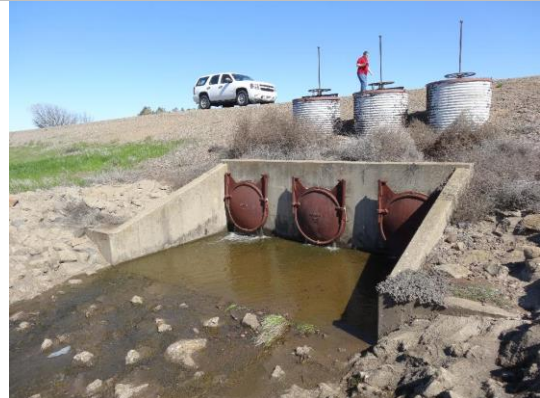
Photo 1 of 2 : UCIP\_SP\_2019\_32105\_58608.jpg

WS view: U type concrete headwall and three CMPs with slide gates on levee slope. Grouted riprap spillway.

Comment Code						
Inspector Comment						
FS_ID:32105 DS_ID:19277 EP_NO: N/A Repair Type: No Action Needed Crossing Status: Found UCIP Comments: Slide gate in CMP riser on waterside.The culvert was working during the field visit. FIELD_STRUCT_DESC: 2 of 3: 48-inch corrugated metal gravity drainage pipe through the levee, 11.7 feet below the crown. Slide gate in a riser well on the waterside (WS) slope. Concrete U-shaped headwall on each end. Flap gate on the WS end. Grouted riprap outlet channel on the WS. [Additional Reference(s): DWR Levee Log, 1992. USACE Sacramento O&M Manual 504, May 1965, (HLM 0.39)]. FS Date: 3/11/2014

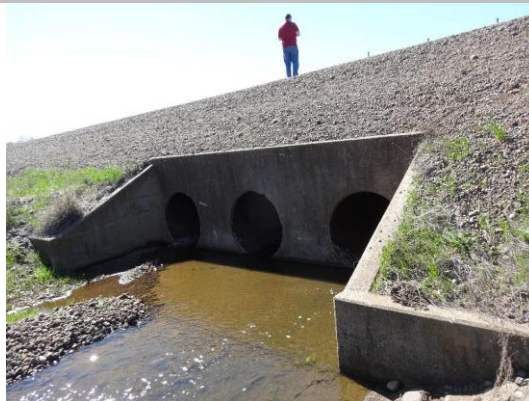
Photo 2 of 2 : UCIP\_SP\_2019\_32106\_58609.jpg

Comment Code						
Inspector Comment						
FS_ID:32106						
DS_ID:19263						
EP_NO: N/A						
Repair Type: No Action Needed						
Crossing Status: Found						
UCIP Comments: Slide gate in CMP riser on waterside.The culvert was working during the field visit.						
FIELD_STRUCT_DESC: 3 of 3: 48-inch corrugated metal gravity drainage pipe through the levee, 11.7 feet below the crown. Slide gate in a riser well on the waterside (WS) slope. Concrete U-shaped headwall on each end. Flap gate on the WS end. Grouted riprap outlet channel on the WS. [Additional Reference(s): DWR Levee Log, 1992. USACE Sacramento O&M Manual 504, May 1965, (HLM 0.39)].						
FS Date: 3/11/2014

LS view: U type concrete headwall and three CMPs on levee slope. Soil/mud on inlet box.

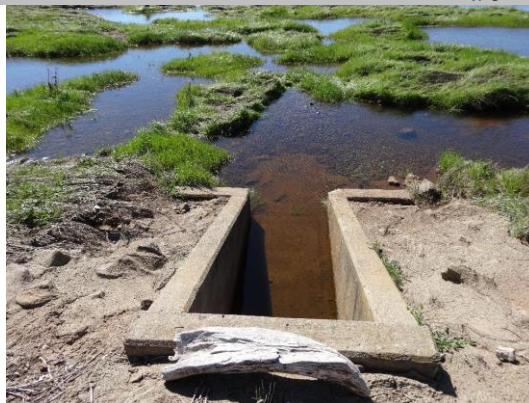
Photo 1 of 3 : UCIP\_SP\_2019\_32107\_58613.jpg

WS view: U type concrete headwall and grouted riprap on levee slope.

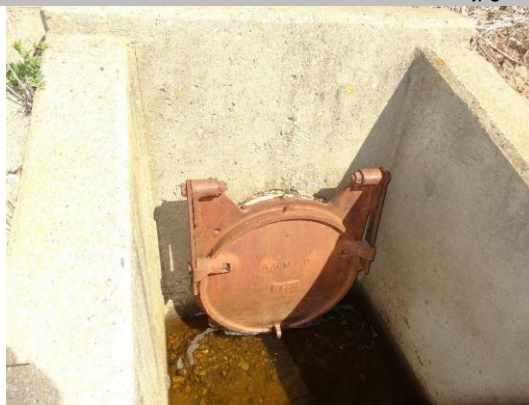
Photo 2 of 3 : UCIP\_SP\_2019\_32107\_58612.jpg

WS view: U type concrete headwall, flapgate, and CMP on levee slope.

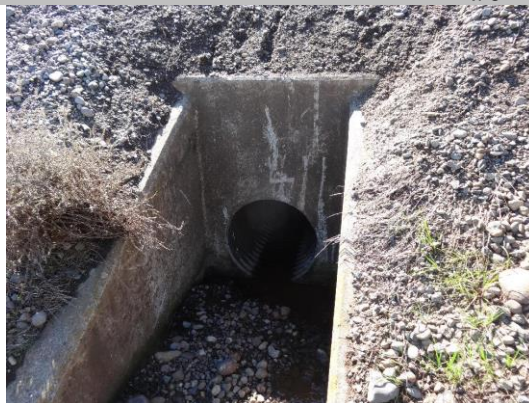
Photo 3 of 3 : UCIP\_SP\_2019\_32107\_58611.jpg

LM Start	1.25	Rating **	A/W	Issue No.	32 (cont)	
LM End	1.25	Issue Type +	Ma	Location *		
Category	Supplemental			GPS Latitude/Longitude		
				Start	End	
Item	DWR UCIP LMA Responsibility			39.779678 °	39.779678 °	
				-121.862632 °	-121.862632 °	
DWR ID	19264					
Comment Code						
Inspector Comment						
FS_ID:32107						
DS_ID:19264						
EP_NO: N/A						
Repair Type: No Action Needed						
Crossing Status: Found						
UCIP Comments: The culvert was working during the field visit.						
FIELD_STRUCT_DESC: 24-inch corrugated metal gravity drainage pipe						
through the levee, 11.7 feet below the crown. Flap gate on the						
waterside (WS) end. Concrete U-shaped headwall on each end.						
[Additional Reference(s): DWR Levee Log, 1992. USACE Sacramento						
O&M Manual 504, May 1965, (HLM 1.28)].						
FS Date: 3/11/2014

LS view: U type concrete headwall and CMP on levee slope.

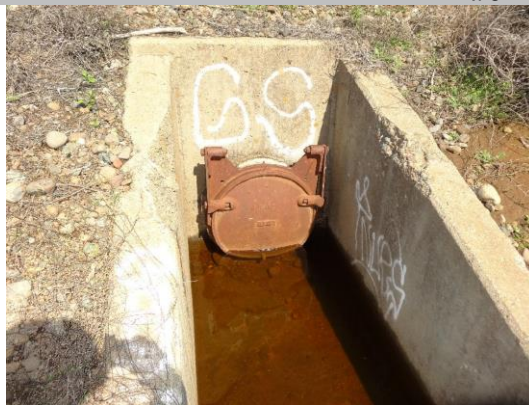
Photo 1 of 2 : UCIP\_SP\_2019\_31899\_58187.jpg

LM Start	1.50	Rating **	A/W	Issue No.	33
LM End	1.50	Issue Type +	Ma	Location *	
Category	Supplemental			GPS Latitude/Longitude	
				Start	End
Item	DWR UCIP LMA Responsibility			39.779230 °	39.779230 °
				-121.857945 °	-121.857945 °
DWR ID	19265				
Comment Code					
Inspector Comment					
FS_ID:31899 DS_ID:19265 EP_NO: N/A Repair Type: No Action Needed Crossing Status: Found UCIP Comments: Working during the field visit. FIELD_STRUCT_DESC: 24-inch corrugated metal gravity drainage pipe through the levee, 11 feet below the crown. Flap gate on the waterside (WS) end. Concrete U-shaped headwall on each end. Grouted riprap apron on each end. [Additional Reference(s): DWR Levee Log, 1992. USACE Sacramento O&M Manual 504, May 1965, (HLM 1.53)]. FS Date: 3/11/2014

WS view: U type concrete headwall, flapgate, and CMP on levee slope.  
Looks clean and clear.

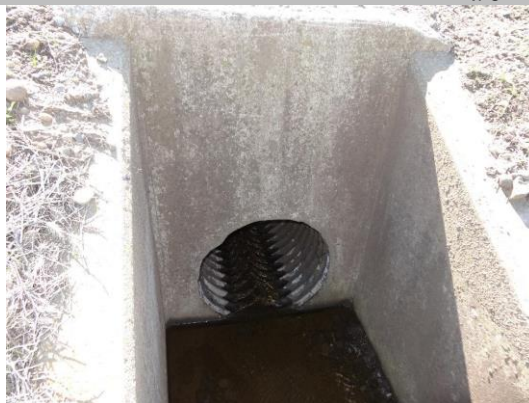
Photo 2 of 2 : UCIP\_SP\_2019\_31899\_58186.jpg

LM Start	1.50	Rating **	A/W	Issue No.	33 (cont)	
LM End	1.50	Issue Type +	Ma	Location *		
Category	Supplemental			GPS Latitude/Longitude		
				Start		End
Item	DWR UCIP LMA Responsibility			39.779230 °		39.779230 °
				-121.857945 °		-121.857945 °
DWR ID	19265					
Comment Code						
Inspector Comment						
FS_ID:31899						
DS_ID:19265						
EP_NO: N/A						
Repair Type: No Action Needed						
Crossing Status: Found						
UCIP Comments: Working during the field visit.						
FIELD_STRUCT_DESC: 24-inch corrugated metal gravity drainage pipe through the levee, 11 feet below the crown. Flap gate on the waterside (WS) end. Concrete U-shaped headwall on each end. Grouted riprap apron on each end. [Additional Reference(s): DWR Levee Log, 1992. USACE Sacramento O&M Manual 504, May 1965, (HLM 1.53)].						
FS Date: 3/11/2014

LS view: U type concrete headwall and CMP on levee slope. Looks clean and clear.

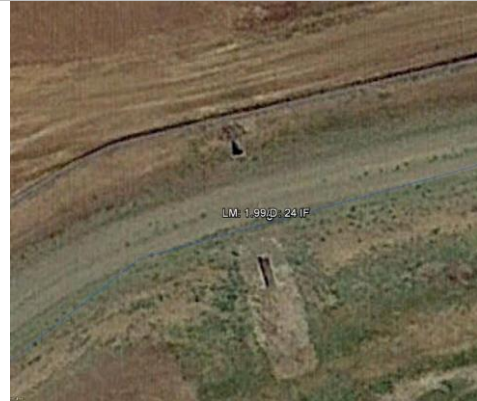
Photo 1 of 1 : UCIP\_SP\_2019\_31900\_58189.jpg

LM Start	1.96	Rating **	M	Issue No.	34
LM End	1.96	Issue Type +	En	Location *	
Category	Supplemental			GPS Latitude/Longitude	
				Start	End
Item	DWR UCIP Field Study			39.781714 °	39.781714 °
				-121.850868 °	-121.850868 °
DWR ID	19266				
Comment Code					
Inspector Comment					
FS_ID:31900 DS_ID:19266 EP_NO: N/A Repair Type: Non-Urgent Crossing Status: Indicator Found UCIP Comments: Needs location confirmation, GPS reading has not taken due to access problem. FIELD_STRUCT_DESC: 24-inch corrugated metal gravity drainage pipe through the levee, 8 feet below the crown. Flap gate on the waterside (WS) end. Concrete U-shaped headwall on each end. Grouted riprap apron on the landside (LS) end. Grouted riprap spillway on the WS end. [Additional Reference(s): DWR Levee Log, 1992. USACE Sacramento O&M Manual 504, May 1965, (HLM 2.00)]. FS Date: 3/11/2014

Bird's eye view: concrete headwall visible on both sides of the levee. Grouted riprap spillway on waterside.

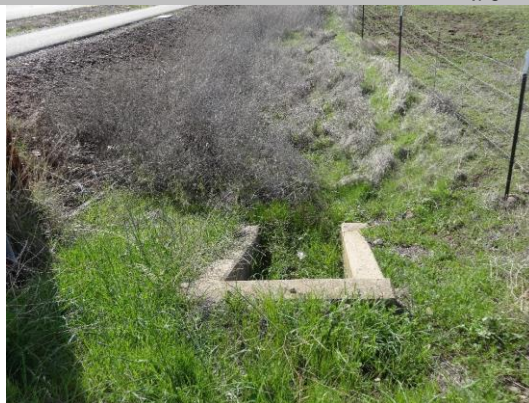
Photo 2 of 3 : UCIP\_SP\_2019\_32124\_58624.jpg

LM Start	2.17	Rating **	M	Issue No.	35 (cont)	
LM End	2.17	Issue Type +	Ma	Location *		
Category	Supplemental			GPS Latitude/Longitude		
				Start	End	
Item	DWR UCIP LMA Responsibility			39.785290 °	39.785290 °	
				-121.844235 °	-121.844235 °	
DWR ID	19267					
Comment Code						
Inspector Comment						
FS_ID:32124 DS_ID:19267 EP_NO: N/A Repair Type: Non-Urgent Crossing Status: Found UCIP Comments: Pipe is about 4 feet below the crown. Needs cleaning and clearing the culvert. FIELD_STRUCT_DESC: 24-inch corrugated metal gravity drainage pipe through the levee, 6 feet below the crown. Flap gate on the waterside (WS) end. Concrete U-shaped headwall on each end. [Additional Reference(s): DWR Levee Log, 1992. USACE Sacramento O&M Manual 504, May 1965, (HLM 2.23)]. FS Date: 3/7/2014

LS view: U type concrete headwall of CMP culvert on levee slope. Vegetation on inlet box.

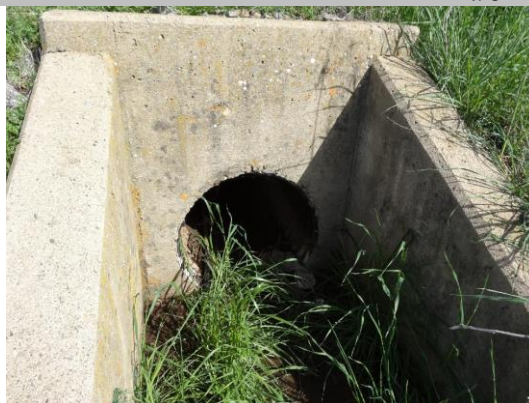
Photo 3 of 3 : UCIP\_SP\_2019\_32124\_58627.jpg

LS view: inside view of CMP on levee slope. Needs cleaning and clearing.

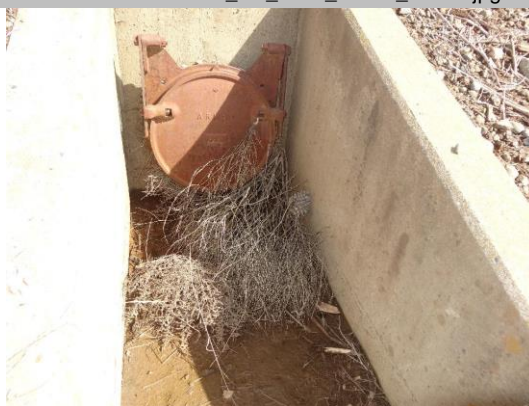
Photo 1 of 3 : UCIP\_SP\_2019\_31901\_58194.jpg

WS view: U type concrete headwall, flapgate, and CMP on levee slope.  
Needs cleaning and clearing.

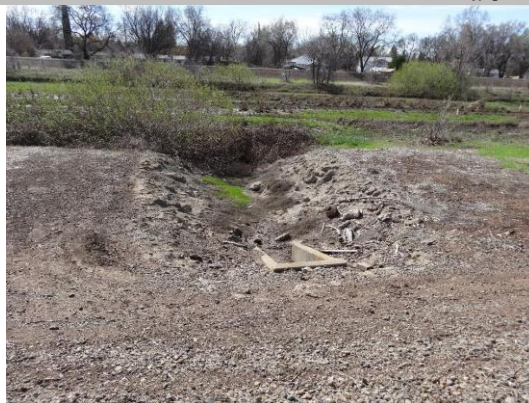
Photo 1 of 3 : UCIP\_SP\_2019\_31902\_58201.jpg

WS view: U type concrete headwall and grouted riprap spillway on levee slope.

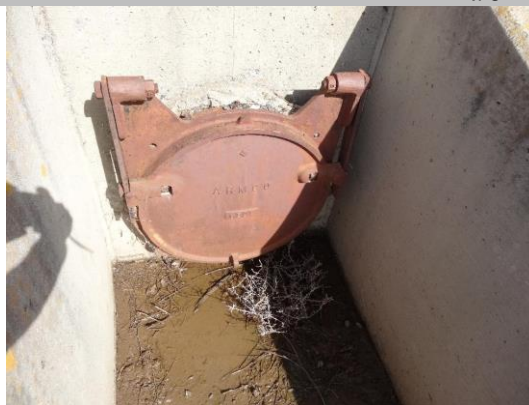
Photo 2 of 3 : UCIP\_SP\_2019\_31902\_58200.jpg

WS view: U type concrete headwall and CMP on levee slope.

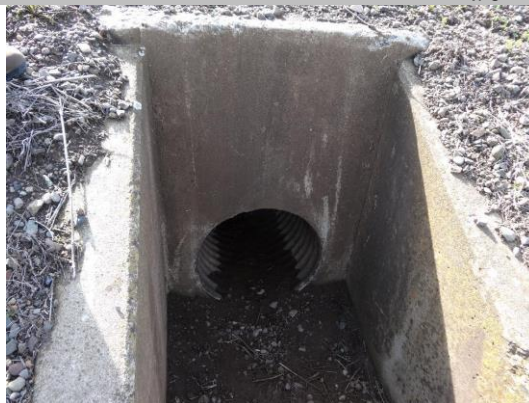
Photo 2 of 3 : UCIP\_SP\_2019\_31864\_58068.jpg

LS view: U type concrete headwall and CMP on levee slope. Soil/mud on inlet box.

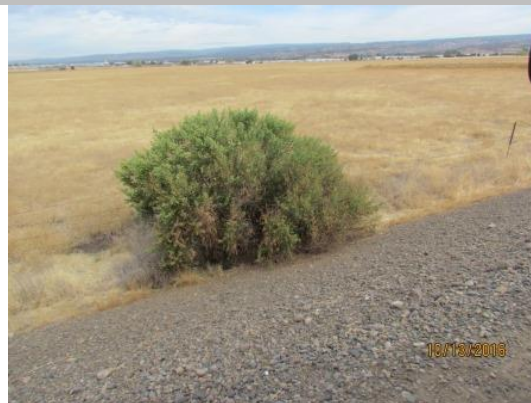
Photo 1 of 1 : SP\_2019\_NA0003\_67\_14\_20190325\_00003.jpg

LM Start	3.38	Rating **	M	Issue No.	14
LM End	3.38	Issue Type +	Ma	Location *	LS
Category	Earthen Levee			GPS Latitude/Longitude	
				Start	End
Item	Vegetation			39.777429 °	39.777429 °
				-121.848937 °	-121.848937 °
DWR ID	DWR_NA0003_03_f_2016_14				
Comment Code					
V2 : Remove the wild growth other than native grasses from the levee slopes.					
Inspector Comment

View of a bush along the landside toe.

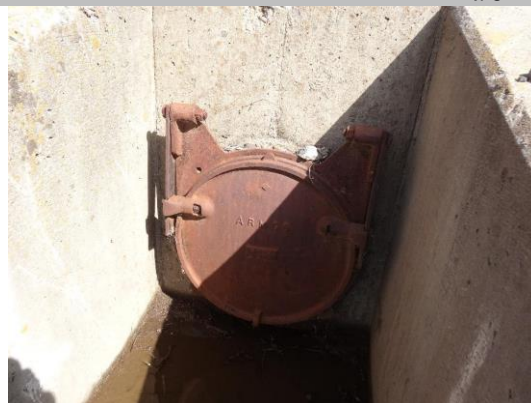
Photo 1 of 3 : UCIP\_SP\_2019\_31856\_58053.jpg

WS view: U type concrete headwall, pipe, and flapgate on levee slope.  
Soil/mud on outlet box.

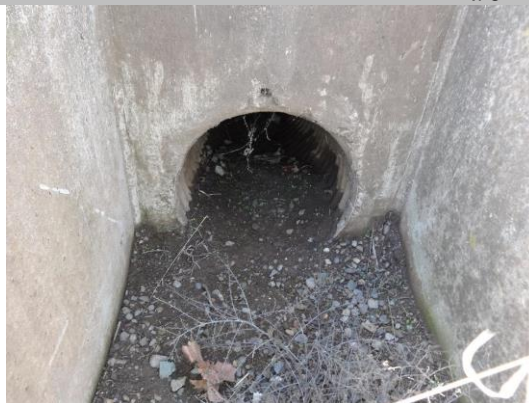
Photo 2 of 3 : UCIP\_SP\_2019\_31856\_58052.jpg

LS view: U type concrete headwall and CMP on levee slope. Soil/mud on inlet box.

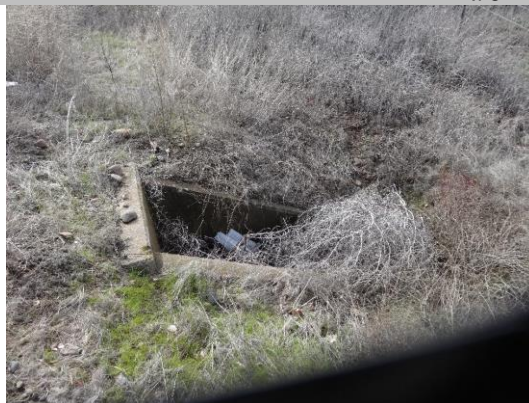
Photo 2 of 2 : UCIP\_SP\_2019\_32125\_58628.jpg

Comment Code						
Inspector Comment						
FS_ID:32125 DS_ID:19275 EP_NO: N/A Repair Type: Non-Urgent Crossing Status: Found UCIP Comments: The culvert was working during the field visit.Needs cleaning and clearing on both ends of the pipe. FIELD_STRUCT_DESC: 24-inch corrugated metal gravity drainage pipe through the levee, 7.5 feet below the crown. Flap gate on the waterside (WS) end. Concrete U-shaped headwall on each end. Grouted riprap apron on the landside (LS) end. Grouted riprap spillway on the WS end. [Additional Reference(s): DWR Levee Log, 1992. USACE Sacramento O&M Manual 504, May 1965, (HLM 3.76)]. FS Date: 3/4/2014

LS view: U type concrete headwall and pipe on levee slope. Soil/mud on inlet box. Vegetation debris blocking inlet box.

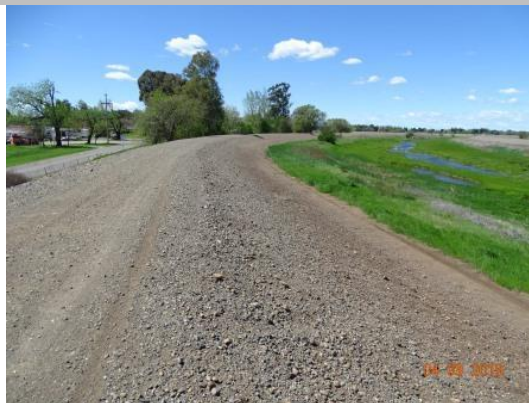
Photo 1 of 1 : SP\_2019\_NA0003\_68\_5\_20190415\_00036.jpg

LM Start	0.00	Rating **	A	Issue No.	5
LM End	2.85	Issue Type +	Ma	Location *	WS
Category	Earthen Levee			GPS Latitude/Longitude	
				Start	End
Item	Vegetation			39.776060 °	39.784655 °
				-121.845856 °	-121.882883 °
DWR ID	DWR_NA0003_04_s_2012_5				
Comment Code					
V1 : Control annual grass and weeds on the levee slopes and easements.					
Inspector Comment					
Excellent vegetation control on the waterside slope.

View of the vegetation control on the waterside slope. Spring 2019.

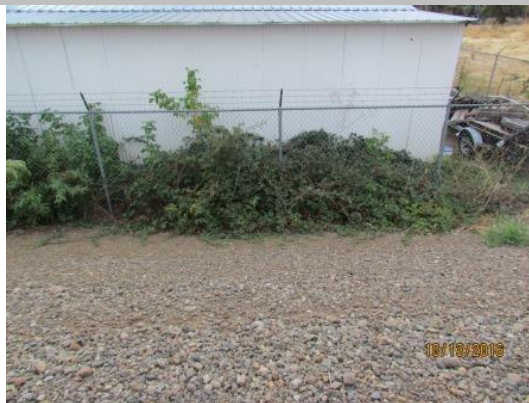
Photo 1 of 1 : SP\_2019\_NA0003\_68\_20\_20190325\_00005.jpg

LM Start	0.16	Rating **	M	Issue No.	20
LM End	0.16	Issue Type +	Ma	Location *	LS
Category	Earthen Levee			GPS Latitude/Longitude	
				Start	End
Item	Vegetation			39.776526 °	39.776526 °
				-121.848727 °	-121.848727 °
DWR ID	DWR_NA0003_04_f_2016_20				
Comment Code					
V2 : Remove the wild growth other than native grasses from the levee slopes.					
Inspector Comment

View of the vegetation along the landside toe.

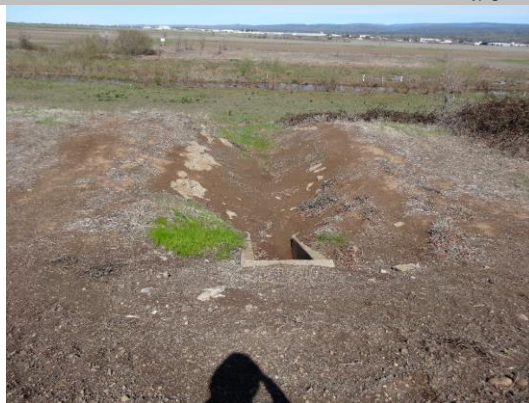
Photo 1 of 3 : UCIP\_SP\_2019\_32026\_58520.jpg

WS view: concrete headwall and grouted riprap spillway on levee slope.

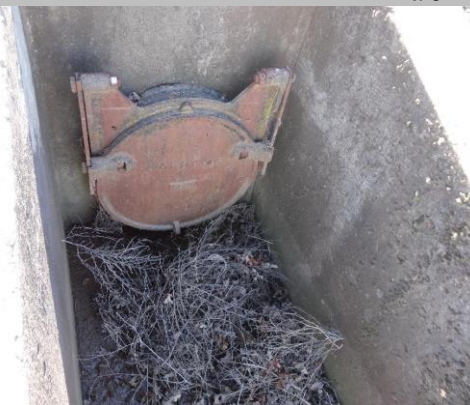
Photo 2 of 3 : UCIP\_SP\_2019\_32026\_58519.jpg

WS view: U type concrete headwall and CMP on levee slope. Mud and vegetation debris on outlet box.

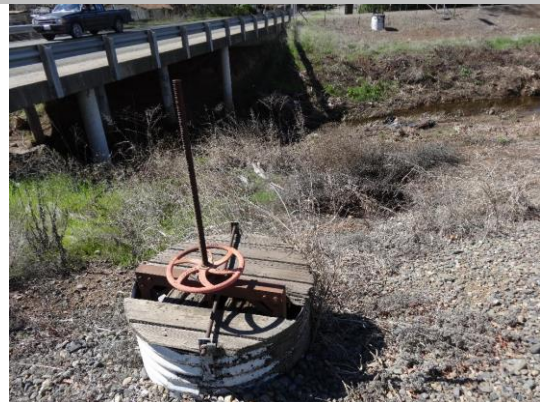
Photo 1 of 3 : UCIP\_SP\_2019\_32025\_58512.jpg

WS view: slide gate in CMP riser on waterside shoulder.

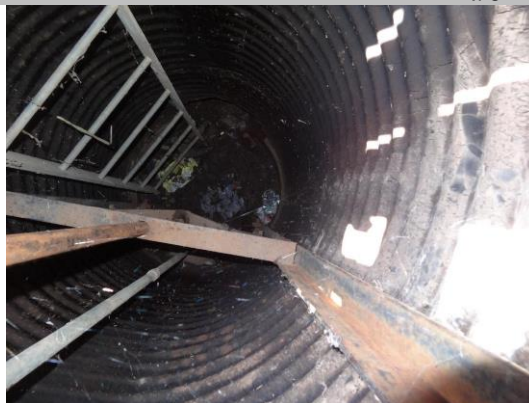
Photo 2 of 3 : UCIP\_SP\_2019\_32025\_58511.jpg

Comment Code						
Inspector Comment						
FS_ID:32025 DS_ID:19280 EP_NO: N/A Repair Type: Non-Urgent Crossing Status: Found UCIP Comments: Slide gate in a CMP riser. Vegetation debris and mud on inlet box.Needs cleaning and clearing the culvert. FIELD_STRUCT_DESC: 24-inch corrugated metal gravity drainage pipe through the levee and under the channel, 9.5 feet below the crown. Slide gate in a corrugated metal pipe (CMP) riser on the waterside (WS) slope. Concrete U-shaped headwall on the landside (LS) end. [Additional Reference(s): DWR Levee Log, 1992. USACE Sacramento O&M Manual 504, May 1965, (HLM 0.34)]. FS Date: 3/7/2014

WS view: inside view of slide gate in CMP riser on waterside shoulder.  
Debris trapped in the riser.

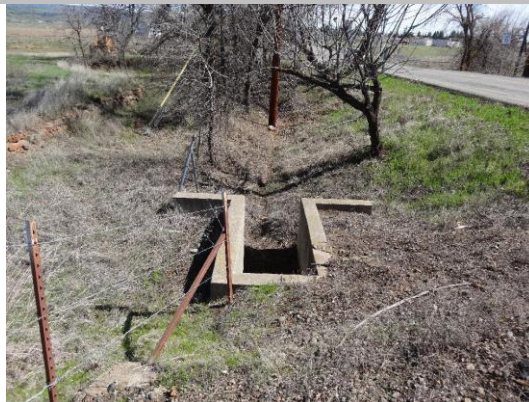
Photo 3 of 3 : UCIP\_SP\_2019\_32025\_58510.jpg

LS view: U type concrete headwall and CMP on levee slope. Vegetation debris and mud on inlet box.

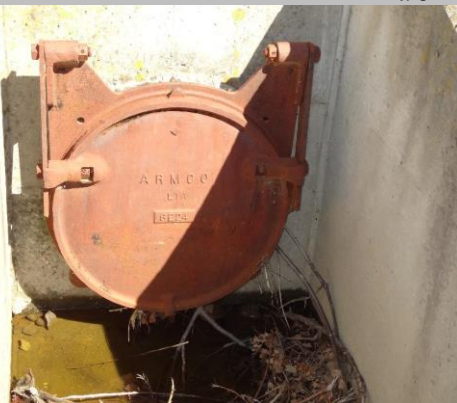
Photo 1 of 3 : UCIP\_SP\_2019\_32023\_58505.jpg

WS view: U type concrete headwall and CMP on levee slope. Vegetation debris and mud on outlet box. Needs cleaning and clearing.

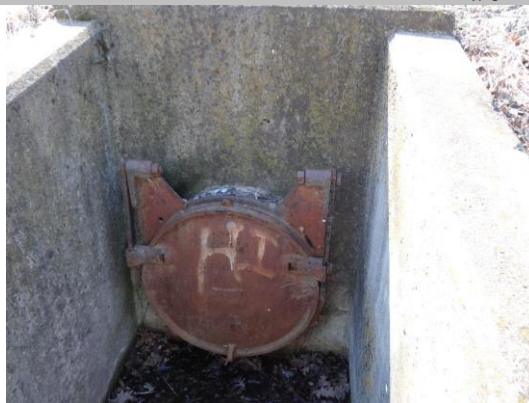
Photo 1 of 2 : UCIP\_SP\_2019\_32143\_58641.jpg

WS view: U type concrete headwall and CMP on levee slope. Soil/mud on outlet box. Needs cleaning and clearing.

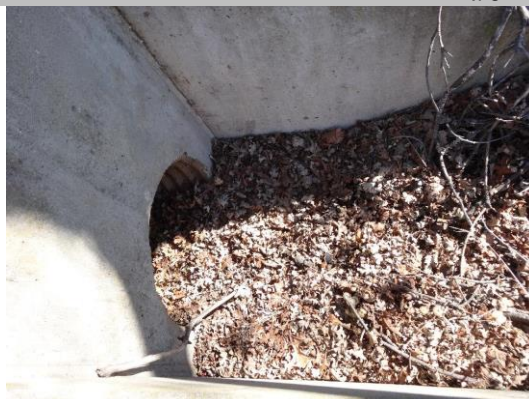
Photo 2 of 2 : UCIP\_SP\_2019\_32143\_58640.jpg

LS view: U type concrete headwall and CMP on levee slope. Vegetation and mud on inlet box.

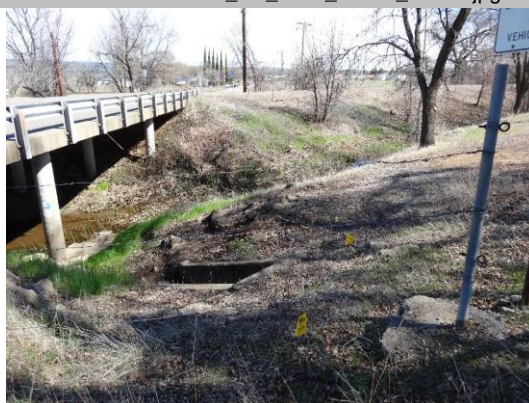
Photo 1 of 2 : UCIP\_SP\_2019\_31946\_58357.jpg

WS view: little gasoline indicator (yellow flags) on both sides of the levee.

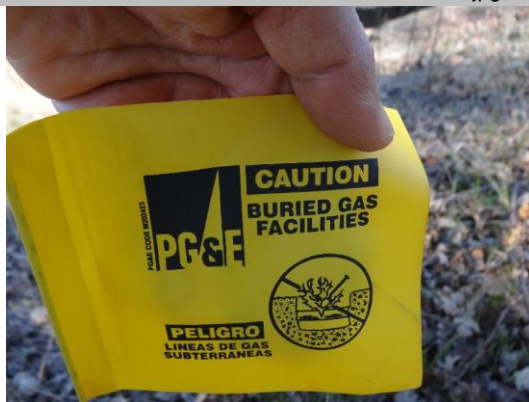
Photo 2 of 2 : UCIP\_SP\_2019\_31946\_58356.jpg

WS view: close up view of little gasoline indicator.

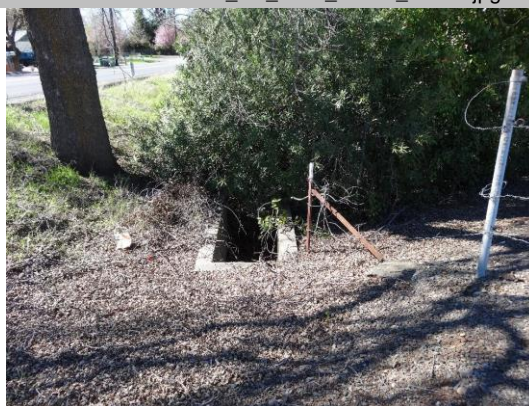
Photo 1 of 3 : UCIP\_SP\_2019\_32144\_58644.jpg

LS view: U type concrete headwall of CMP culvert on levee slope. Vegetation debris and mud on inlet box.

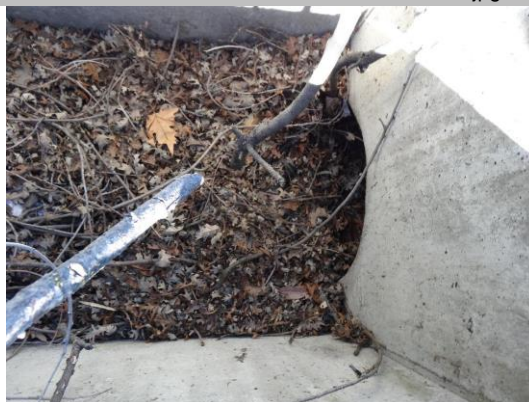
Photo 2 of 3 : UCIP\_SP\_2019\_32144\_58643.jpg

LS view: close view of vegetation debris and mud on inlet box.

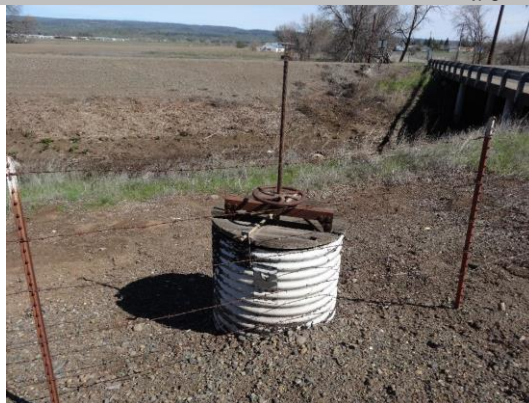
Photo 3 of 3 : UCIP\_SP\_2019\_32144\_58642.jpg

Item	DWR UCIP LMA Responsibility		39.775899 °	39.775899 °								
			-121.851124 °	-121.851124 °								
DWR ID	19288											
Comment Code												
Inspector Comment												
FS_ID:32144 DS_ID:19288 EP_NO: N/A Repair Type: Non-Urgent Crossing Status: Found UCIP Comments: Slide gate in CMP riser on waterside. No access to CMP riser. Needs cleaning and clearing the culvert. FIELD_STRUCT_DESC: 24-inch corrugated metal gravity drainage pipe through the levee and under the channel, 9.5 feet below the crown. Slide gate in a pipe riser on the waterside (WS) slope. Concrete U-shaped headwall on the landside (LS) end. [Additional Reference(s): DWR Levee Log, 1992. USACE Sacramento O&M Manual 504, May 1965, (HLM 0.98)]. FS Date: 3/7/2014

WS view: slide gate in CMP riser on waterside. No access to CMP riser.

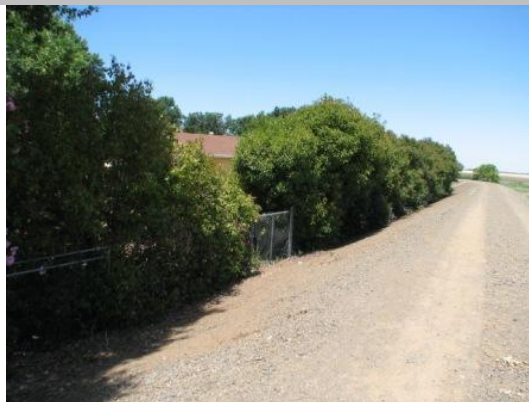
Photo 1 of 1 : SP\_2019\_NA0003\_68\_1\_20190325\_00001.jpg

LM Start	<b>0.94</b>	Rating **	M	Issue No.	<b>1</b>							
LM End	<b>1.01</b>	Issue Type +	En	Location *	LS							
Category	Earthen Levee		GPS Latitude/Longitude									
			Start	End								
Item	Encroachments		39.776013 °	39.776595 °								
			-121.851175 °	-121.852005 °								
DWR ID	DWR_NA0003_04_s_2012_1											
Comment Code												
FE : Fence												
Inspector Comment

View of the fence and trees along the landside toe of the levee.

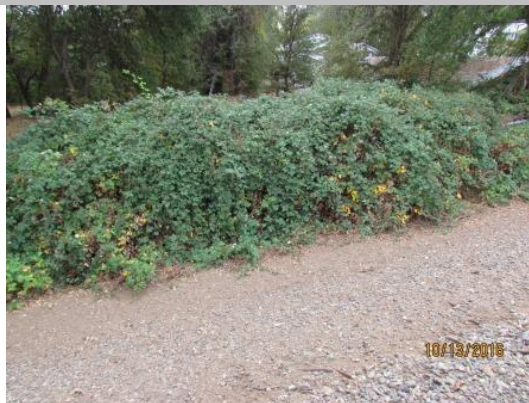
Photo 1 of 1 : SP\_2019\_NA0003\_68\_23\_20190325\_00007.jpg

LM Start	1.04	Rating **	M	Issue No.	23
LM End	1.04	Issue Type +	Ma	Location *	LS
Category	Earthen Levee			GPS Latitude/Longitude	
				Start	End
Item	Vegetation			39.776589 °	39.776589 °
				-121.852600 °	-121.852600 °
DWR ID	DWR_NA0003_04_f_2016_23				
Comment Code					
V2 : Remove the wild growth other than native grasses from the levee slopes.					
Inspector Comment

View of the blackberries blocking visibility and access.

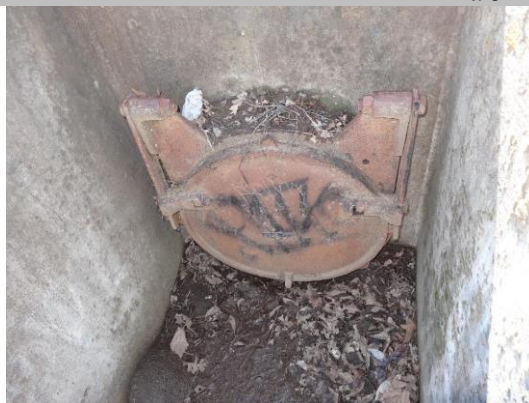
Photo 1 of 3 : UCIP\_SP\_2019\_31963\_58384.jpg

WS view: U type concrete headwall and CMP on levee slope. Vegetation debris and mud on outlet box. Needs cleaning and clearing.

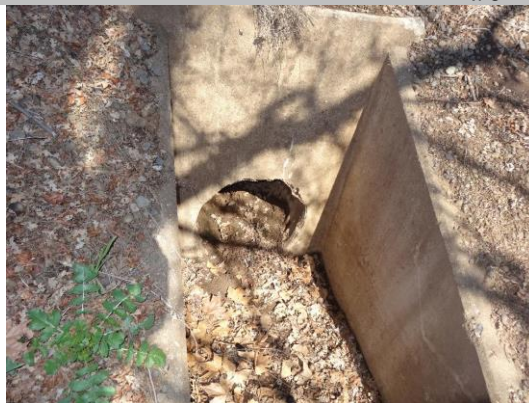
Photo 2 of 3 : UCIP\_SP\_2019\_31963\_58383.jpg

LS view: U type concrete headwall and CMP on levee slope. Vegetation debris and mud on inlet box.

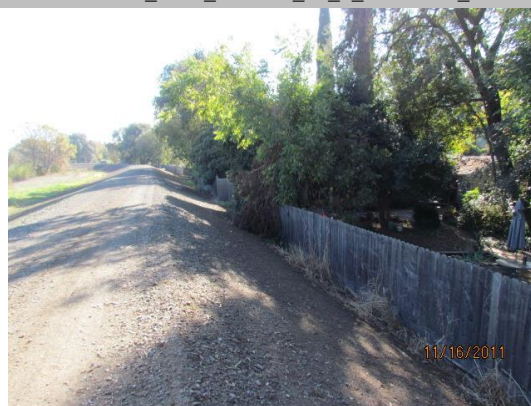
Photo 1 of 1 : SP\_2019\_NA0003\_68\_3\_20190325\_00003.jpg

LM Start	1.11	Rating **	U	Issue No.	3
LM End	1.22	Issue Type +	En	Location *	LS
Category	Earthen Levee			GPS Latitude/Longitude	
				Start	End
Item	Encroachments			39.777600 °	39.777650 °
				-121.854022 °	-121.855687 °
DWR ID	DWR_NA0003_04_s_2012_3				
Comment Code					
FE : Fence					
Inspector Comment

View of the fence along the landside toe.

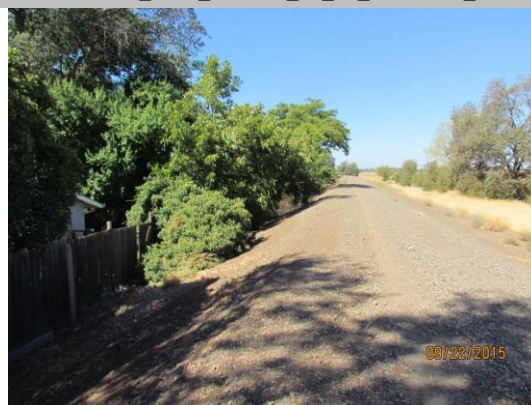
Photo 1 of 1 : SP\_2019\_NA0003\_68\_17\_20190325\_00004.jpg

LM Start	1.16	Rating **	M	Issue No.	17
LM End	1.22	Issue Type +	Ma	Location *	LS
Category	Earthen Levee			GPS Latitude/Longitude	
				Start	End
Item	Trim / Thin Trees			39.777128 °	39.777580 °
				-121.854763 °	-121.855612 °
DWR ID	DWR_NA0003_04_f_2015_17				
Comment Code					
T2 : Thin trees to allow visibility of the ground and room to flood fight.					
Inspector Comment					
Trees smaller than 4-inches in diameter at chest height should be removed. All other trees should be trimmed.

View of the trees overhanging the levee slope.

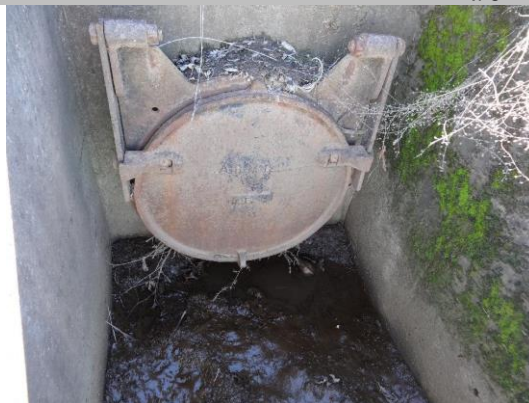
Photo 1 of 2 : UCIP\_SP\_2019\_31964\_58389.jpg

LM Start	1.35	Rating **	M	Issue No.	49
LM End	1.35	Issue Type +	Ma	Location *	
Category	Supplemental			GPS Latitude/Longitude	
				Start	End
Item	DWR UCIP LMA Responsibility			39.778370 °	39.778370 °
				-121.857904 °	-121.857904 °
DWR ID	19290				
Comment Code					
Inspector Comment					
FS_ID:31964 DS_ID:19290 EP_NO: N/A Repair Type: Non-Urgent Crossing Status: Found UCIP Comments: Needs cleaning and clearing the culvert. FIELD_STRUCT_DESC: 24-inch corrugated metal gravity drainage pipe through the levee, 13 feet below the crown. Flap gate on the waterside (WS) end. Concrete U-shaped headwall on each end. Grouted riprap apron on the landside (LS) end. Grouted riprap spillway on the WS end. [Additional Reference(s): DWR Levee Log, 1992. USACE Sacramento O&M Manual 504, May 1965, (HLM 1.41)]. FS Date: 3/7/2014

WS view: U type concrete headwall and CMP on levee slope. Vegetation debris and mud in outlet box. Needs cleaning and clearing.

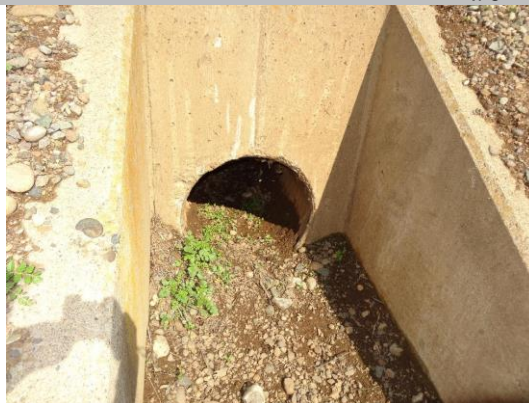
Photo 2 of 3 : UCIP\_SP\_2019\_31965\_58394.jpg

LM Start	2.15	Rating **	M	Issue No.	50 (cont)	
LM End	2.15	Issue Type +	Ma	Location *		
Category	Supplemental			GPS Latitude/Longitude		
				Start		End
Item	DWR UCIP LMA Responsibility			39.782777 °		39.782777 °
				-121.871179 °		-121.871179 °
DWR ID	19291					
Comment Code						
Inspector Comment						
FS_ID:31965 DS_ID:19291 EP_NO: N/A Repair Type: Non-Urgent Crossing Status: Found UCIP Comments: Needs cleaning and clearing the culvert. FIELD_STRUCT_DESC: 24-inch corrugated metal gravity drainage pipe through the levee, 11 feet below the crown. Flap gate on the waterside (WS) end. Concrete U-shaped headwall on each end. Grouted riprap apron on the landside (LS) end. Grouted riprap spillway on the WS end. [Additional Reference(s): DWR Levee Log, 1992. USACE Sacramento O&M Manual 504, May 1965, (HLM 2.22)]. FS Date: 3/7/2014

LS view: U type concrete headwall and CMP on levee slope. Vegetation debris and mud in inlet box.

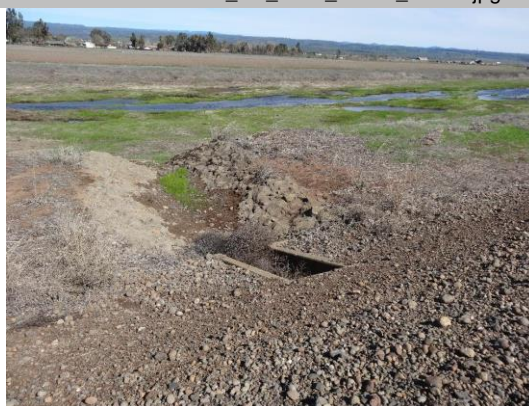
Photo 1 of 3 : UCIP\_SP\_2019\_31966\_58401.jpg

WS view: U type concrete headwall and grouted riprap spillway on levee slope.

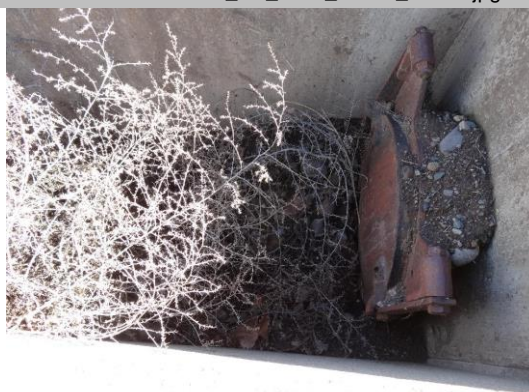
Photo 2 of 3 : UCIP\_SP\_2019\_31966\_58400.jpg

LM Start	2.47	Rating **	M	Issue No.	51
LM End	2.47	Issue Type +	Ma	Location *	
Category	Supplemental			GPS Latitude/Longitude	
				Start	End
Item	DWR UCIP LMA Responsibility			39.784244 °	39.784244 °
				-121.876810 °	-121.876810 °
DWR ID	19292				
Comment Code					
Inspector Comment					
FS_ID:31966					
DS_ID:19292					
EP_NO: N/A					
Repair Type: Non-Urgent					
Crossing Status: Found					
UCIP Comments: Needs cleaning and clearing the culvert.					
FIELD_STRUCT_DESC: 24-inch corrugated metal gravity drainage pipe					
through the levee, 11 feet below the crown. Flap gate on the waterside					
(WS) end. Concrete U-shaped headwall on each end. Grouted riprap					
apron on the landside (LS) end. Grouted riprap spillway on the WS end.					
[Additional Reference(s): DWR Levee Log, 1992. USACE Sacramento					
O&M Manual 504, May 1965, (HLM 2.56)].					
FS Date: 3/7/2014

WS view: U type concrete headwall and CMP on levee slope. Vegetation debris and mud on outlet box. Needs cleaning and clearing.

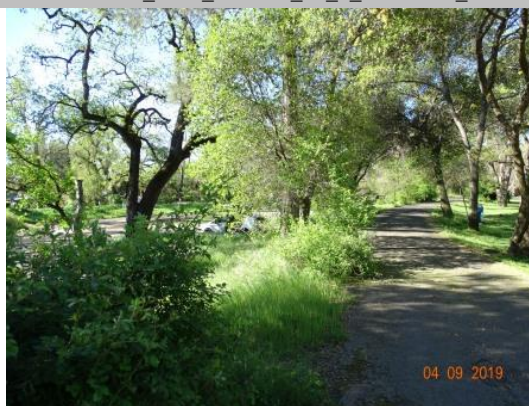
Photo 1 of 1 : SP\_2019\_NA0003\_69\_1\_20190412\_00005.jpg

LM Start	<b>0.03</b>	Rating **	M	Issue No.	<b>1</b>
LM End	<b>0.20</b>	Issue Type +	Ma	Location *	LS
Category	Earthen Levee		GPS Latitude/Longitude		
			Start	End	
Item	Vegetation		39.763164 °	39.761860 °	
			-121.790335 °	-121.792635 °	
DWR ID	DWR_NA0003_05_s_2012_1				
Comment Code					
V2 : Remove the wild growth other than native grasses from the levee slopes.					
Inspector Comment

View of the wild growth on the landside slope. Spring 2019.

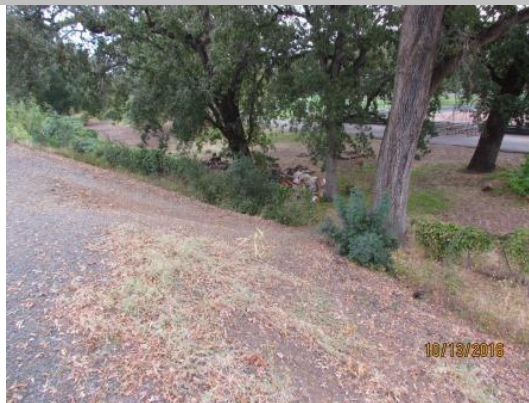
Photo 1 of 1 : SP\_2019\_NA0003\_69\_11\_20190325\_00001.jpg

LM Start	0.42	Rating **	M	Issue No.	11
LM End	0.42	Issue Type +	Ma	Location *	LS
Category	Earthen Levee			GPS Latitude/Longitude	
				Start	End
Item	Slope Stability			39.761077 °	39.761077 °
				-121.796576 °	-121.796576 °
DWR ID	DWR_NA0003_05_f_2016_11				
Comment Code					
S2 : Repair the levee slope damaged by foot traffic and prevent access where possible.					
Inspector Comment

View of the damaged slope by foot traffic.

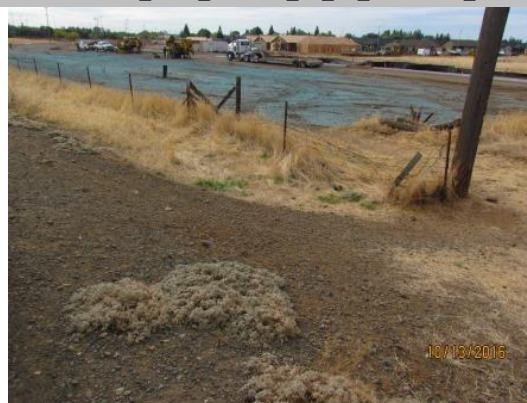
Photo 1 of 1 : SP\_2019\_NA0003\_69\_13\_20190325\_00002.jpg

LM Start	1.25	Rating **	M	Issue No.	13
LM End	1.25	Issue Type +	Ma	Location *	LS
Category	Earthen Levee			GPS Latitude/Longitude	
				Start	End
Item	Slope Stability			39.768621 °	39.768621 °
				-121.807052 °	-121.807052 °
DWR ID	DWR_NA0003_05_f_2016_13				
Comment Code					
S2 : Repair the levee slope damaged by foot traffic and prevent access where possible.					
Inspector Comment

View of the damaged slope by foot traffic.

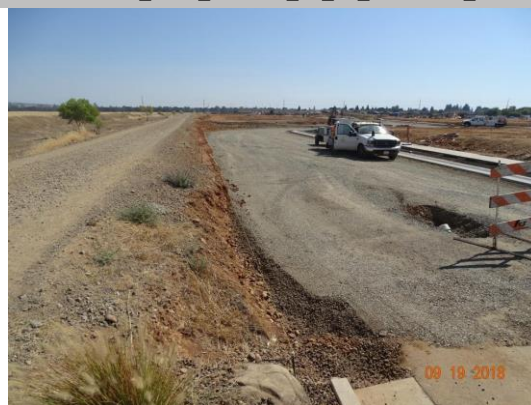
Photo 1 of 2 : SP\_2019\_NA0003\_69\_15\_20190325\_00003.jpg

LM Start	1.56	Rating **	U	Issue No.	15
LM End	1.56	Issue Type +	En	Location *	LS
Category	Earthen Levee			GPS Latitude/Longitude	
				Start	End
Item	Encroachments			39.772190 °	39.772190 °
				-121.810700 °	-121.810700 °
DWR ID	DWR_NA0003_05_f_2017_15				
Comment Code					
RW : Retaining Wall					
Inspector Comment					
The developer cut a paved road, gutter and large rocks in slope/toe of the levee. The board is in the process of resolving the encroachment.

View of the housing track road cutting into the levee toe.

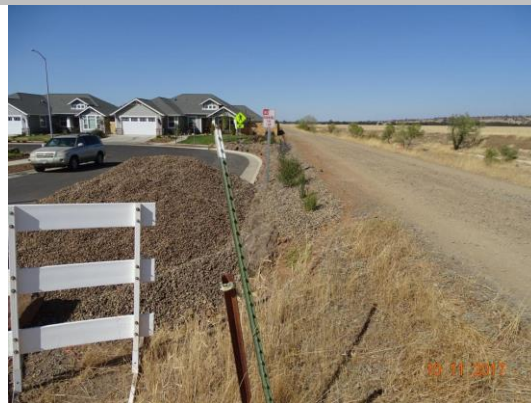
Photo 2 of 2 : SP\_2019\_NA0003\_69\_15\_20190325\_00004.jpg

View of the housing track road cutting into the levees slope and toe.
